Analysis of Pressures on Nagarjuna Sagar Spillway

M V S S Giridhar^{1*}, Madaka Madavi², Ramaraju Anirudh¹ and E Ramakrishna Goud⁴

Abstract

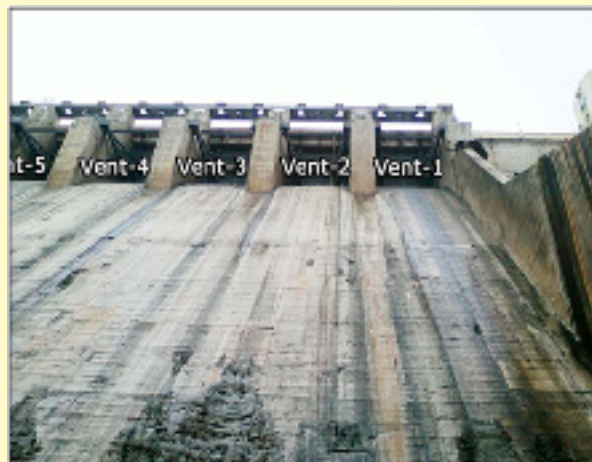
Figure 1A: Cavitation damage on spillway profile of Nagarjunasagar Dam.

The spillway of Nagarjuna Sagar Dam across Krishna River was eroded several during the floods in 2009 due to cavitation which was resulted from the negative pressures developed over the spillway. On further investigation of the problem, it was found that there was a large deviation of the existed profile of the spillway from the design profile, which actually led to the development of negative pressures in such a magnitude that could create the problem. Figure 1A and 1B shows the Cavitation damage on Spillway profile of Nagarjuna Sagar Dam and Cavitation damage on Spillway profile of Nagarjuna Sagar Dam

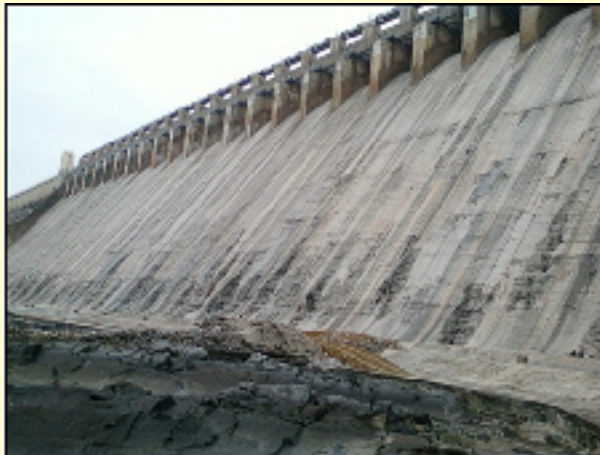
Figure 1B: Cavitation damage on spillway profile of Nagarjunasagar Dam.

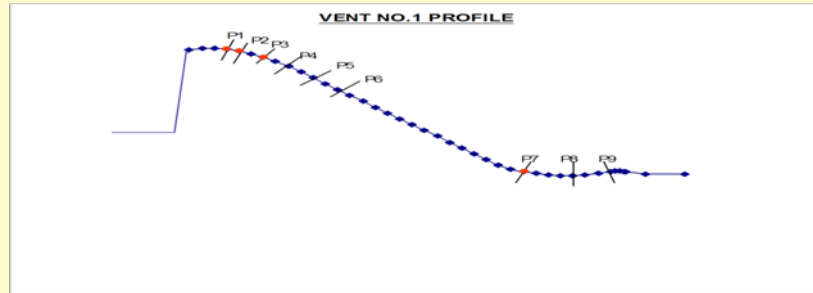
From the results obtained from the experiments, the maximum negative pressures observed at pressure tube points in vent no 1 is 0.079 at P_7 for $1/4^{th}$ of maximum flood discharge for gated condition. Figure 3 shows the negative pressures observed at pressure tube points in vent no.1.

Figure 3: Negative Pressure points on the spillway profile of Vent No 1(Model).

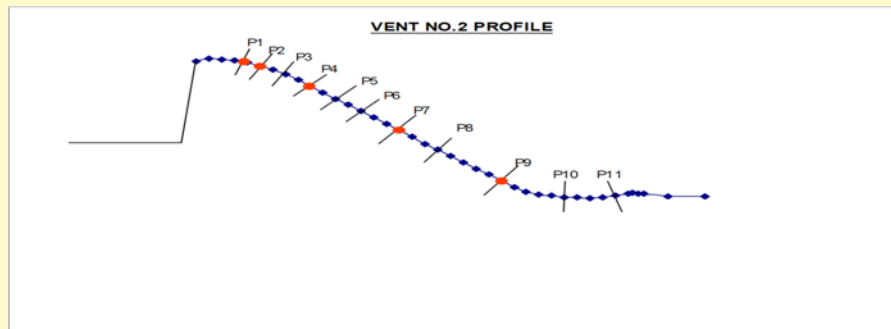
From the results obtained from the experiments, the maximum negative pressures observed at pressure tube points in vent no 2 is 0.031 at P_7 for $3/4^{th}$, $1/2$ and $1/4^{th}$ of maximum flood discharge for free flow condition. Figure 4 shows the negative pressures observed at pressure tube points in vent no.2.

Figure 4: Negative Pressure points on the spillway profile of Vent No 2(Model).

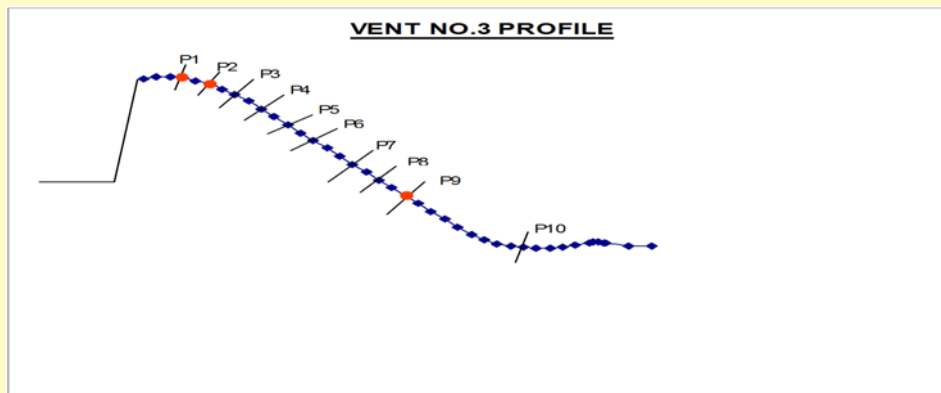
From the results obtained from the experiments in case-I, the maximum negative pressures observed at pressure tube points in vent no 3 is 0.031 at P_2 for $3/4^{th}$ of maximum flood discharge for both free flow and gated conditions and $1/2$ and $1/4^{th}$ of maximum flood discharge for gated condition. Figure 5 shows the negative pressures observed at pressure tube points in vent no.3.

Figure 5: Negative Pressure points on the spillway profile of Vent No 3(Model).
