Intra Oral Camera - Additional Simple Tool in Diagnosis of Infracted and Fractured Tooth Roots

Ćatović A^{1*}, Hrelja M², Ćatović D³, Ćatović Dž³ and Hrelja I⁴

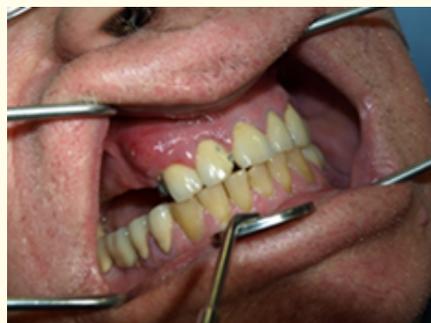
Figure 1: Patient with typical outer signs of upper frontal tooth root fracture.

Diagnosis of VRF are sometimes very simple to set. It includes a typical intraoral finding of acute inflammation with all the signs: pain, swelling and redness of the gingiva, and often, but not always, a chewing problem associated with biting on the affected tooth [3-5]. The diagnosis is completed with retro alveolar x-ray images with clearly visible cracks, specific for the complete fracture of the root with fragments. Some of the fragments can be even movable on palpation. In some cases, previously endodontically threatened roots supplied with readymade or individual upgrades, whose "dropping" from the root canal, can also cause the fracture of the root or "root ferrule" loss. The therapy is clear: urgent and uncompromising removal of all fragments of the fractured tooth. The urgency stems from the fact that the diffuse inflammatory process can lead later in chronic stage, significantly altering the quality and quantity of surrounding bone which later jeopardize implant prosthetic treatment (Figure 1 and 2).

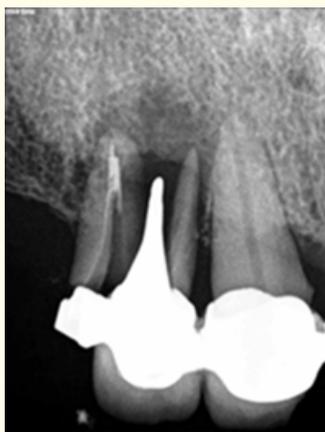
Figure 2: X-ray of the same patient with confirmed vertical root fracture.

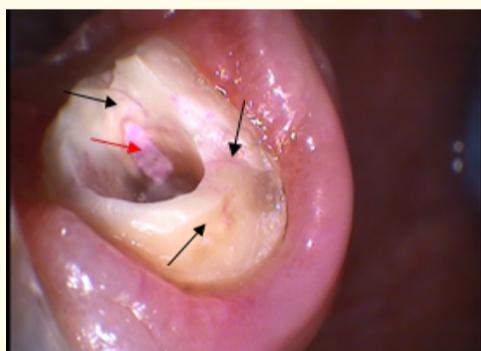
Figure 3: Multiple tooth cracks enlarged by intra oral camera (black arrows) and oral part of the root channel tinned and probably perforated (red arrow).

Intra oral camera (IO) is used to explore the visually accessible surface of each root of the damaged tooth needed for prosthetic reconstruction. Photo resolution of IO cameras plays important role in diagnostic use, increasing the ability to focus on the susceptible surface of the examined tooth (Figure 3).

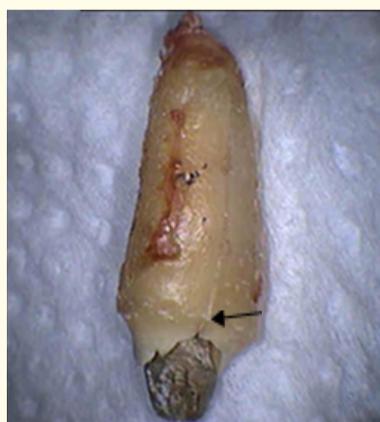
Figure 4: Extracted tooth with casted post and core and visible root fracture (black arrow).

The case of repeatedly failed out and re cemented readymade post and core from the root channel of the first upper incisor is demonstrated in figure 4 and 5. Without visible x-ray signs vestibular fistula persisted for three-year and root fracture was clarified with intra oral photograph after tooth extraction (Figure 4 and 5).

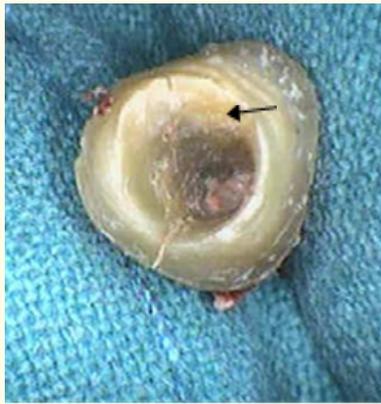
Figure 5: The same tooth after post and core removal and visible root fracture (black arrow).
