Analysis of Pressures on Nagarjuna Sagar Spillway

M V S S Giridhar^{1*}, Madaka Madavi², Ramaraju Anirudh¹ and E Ramakrishna Goud⁴

Abstract

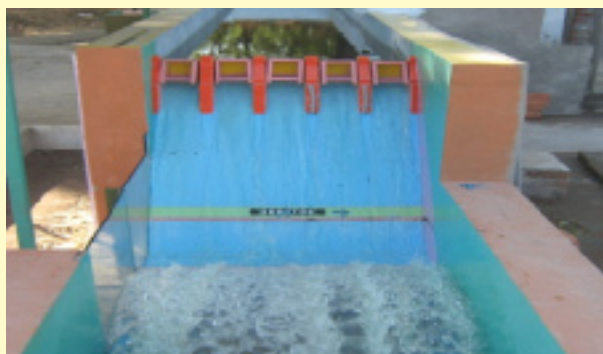
Figure 2: Photograph of the model –all the vents are fully opened.

In the first instance, the experiments were carried out by keeping all the vents of the dam fully open i.e., Free flow condition for various discharge conditions like Maximum Flood Discharge, 3/4th of Maximum Flood Discharge, 1/2 of Maximum Flood Discharge and 1/4th of Maximum Flood Discharge. Figure 2 represents the photograph of the model when all the vents are fully opened. Each discharge condition is explained with the main focus of the studies on the measuring of the pressures at all the points of observation on vent no's 1, 2 and 3.
