## Constricted Pulp Chamber and Dilacerated Roots in Maxillary Wisdom – A New Challenge to Dentist!

**Keywords:** Constricted Pulp Chamber; Dilaceration; Maxillary Third Molar

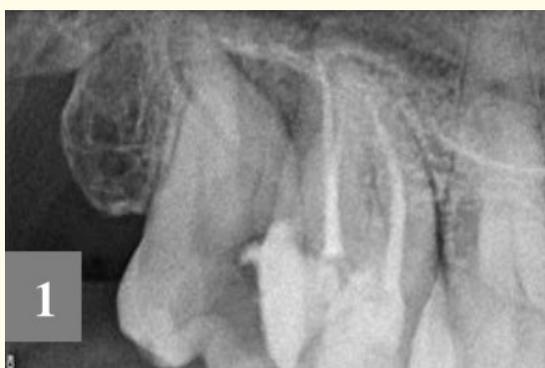
**Figure 1:** Pre-operative radiograph of right MTM.

Since, MTMs are not just the miniature version of maxillary 1<sup>st</sup> molar, one has to be very careful while doing the access opening and locating distobuccal canal particularly to avoid perforation. A good periapical radiograph and use of magnification e.g. Endomicroscope can prevent such mishaps. In the present case, patient reported to our department with the chief complaint of pain in upper right back jaw region since 1 month. No associated swelling, sinus or pus drainage was seen. Past medical history was noncontributory. Periapical radiograph showed proximal caries involving pulp, widening of periodontal ligament and dilacerated roots with #1 (Figure 1). It was diagnosed as chronic symptomatic apical periodontitis with #1.

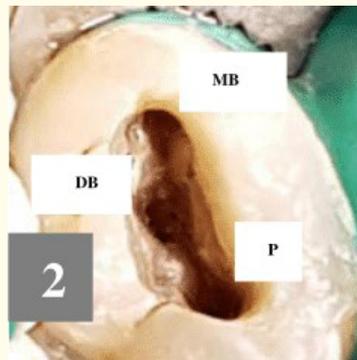
**Figure 2:** Access Cavity.

Local anaesthesia (LOX 2%; Neon, India) and rubber dam isolation was performed. Caries excavation and pre-endodontic filling was done with nanohybrid composite with #1. Access cavity was prepared under endomicroscope (3D Medisys Exports, India) targeting the palatal canal orifice first and then it was carefully extended towards the mesiobuccal canal following the dentinal map. Copious irrigation with 5% sodium hypochlorite (Hyposept, India) was performed in between. While doing this, the third canal orifice of distobuccal canal was located in the center of the tooth across the line connecting the palatal and mesiobuccal canal. When connected all the canal orifices by an imaginary line, it appeared like a letter forming 'C' (Figure 2). Working length was determined by using apex locator & confirming it with radiograph (Figure 3).

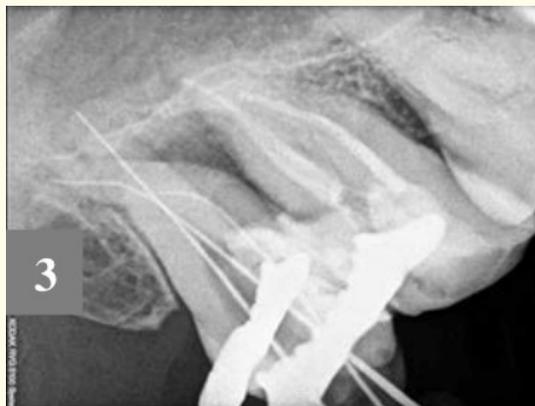
**Figure 3:** Working length determination.

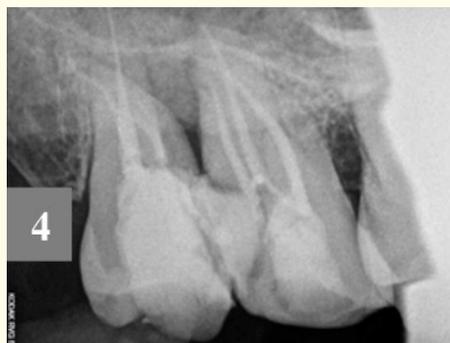
**Figure 4:** Post-operative radiograph.

In next appointment, canals were re-accessed and intra-canal medicament was removed. Copious irrigation with sodium hypochlorite and normal saline was performed. Irrigation with 17% EDTA (Pulpdent, MA) along with ultrasonic activation was done. Obturation was performed using corresponding gutta percha and AH plus sealer. Post endodontic restoration was performed using nanohybrid composite (Figure 4) and patient was referred to Department of Prosthodontics for crown prosthesis.
